Research confirms resiliency of structural masonry in major wind events

Best Practice Lateral bracing at top of wall provides critical connection

Don Beers, PE

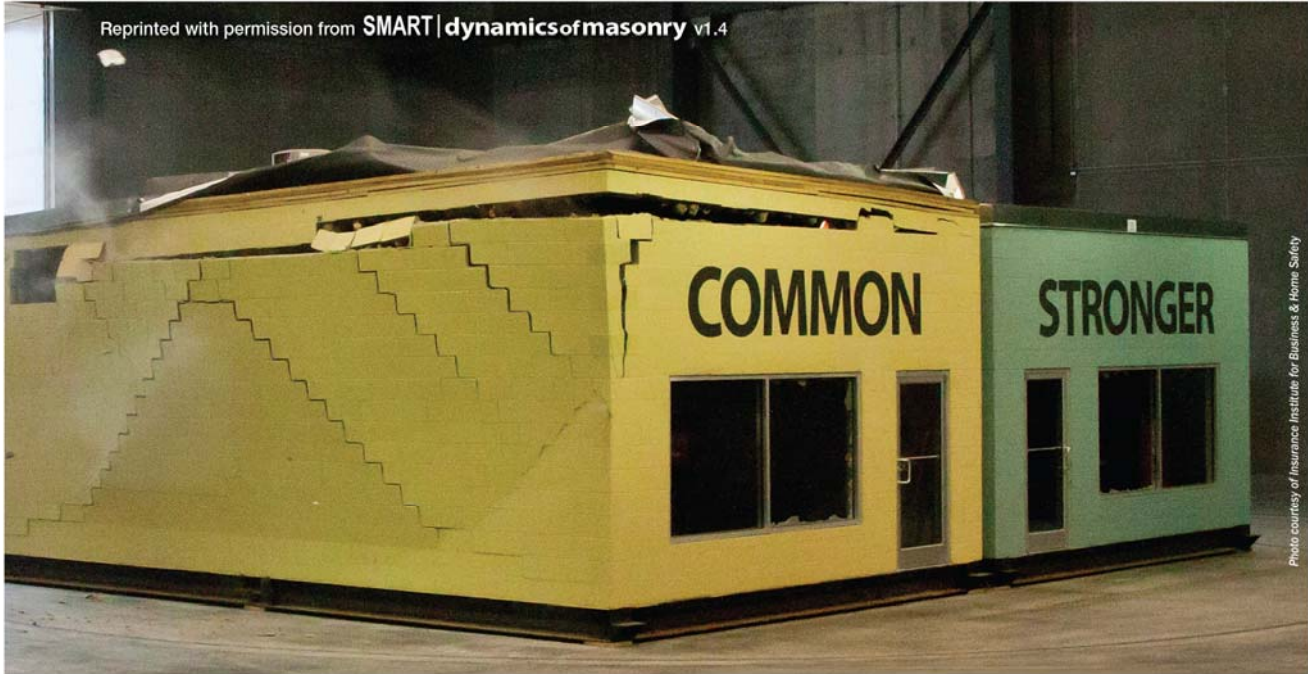
Insurance Institute for Business & Home Safety (IBHS) Research Center performed a high-wind test of commercial masonry structures to determine design and construction best practices. High winds caused roof up-lift, pulling bond beam from top of unreinforced wall, leaving no horizontal support.

The virtual lack of continuity of the wall vertical reinforcement into the bond beam and poor connection to the roof in the *common* building was the primary failure area. Indeed, the *Common* building failed in the wind test in the exact mode I have seen played out in wind storms across Florida. The vertical reinforcement in the wall of the *Common* building lacked adequate connection to the bond beam. Consequently, the net roof up-lift of approximately 45 to 50 psf pulled the bond beam away from the top of the wall leaving no horizontal support for the wall. It had little capacity since it was not designed to act as a cantilevered wall and thus had little means to resist the approximately 35 psf of wall net wind pressure.

The top wind gust during the test was 136 mph, or the equivalent of a 97 mph one-minute sustained wind speed. All wind speeds are referenced to standard open country conditions at an elevation of 10m (33') (Exposure C in wind code terms).

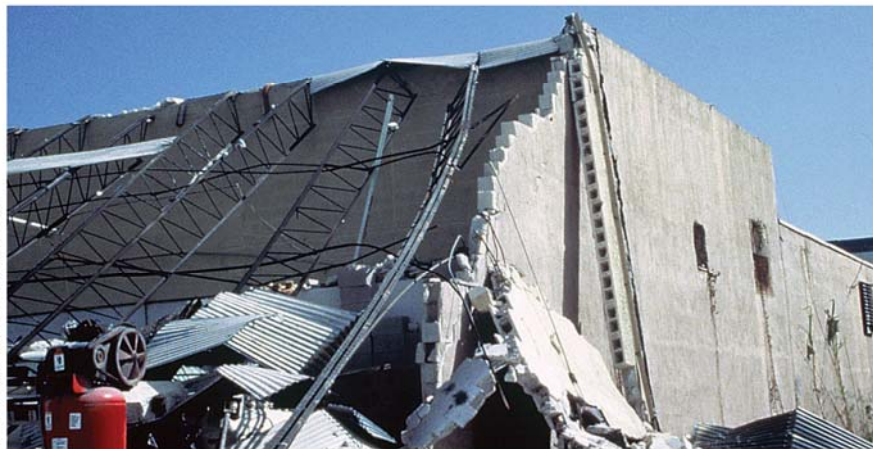
While this wall was well reinforced, there was no tie in between the vertical wall reinforcement and the bond beam. When the winds of Hurricane Andrew blew, both roof and wall failed and the building's interior was demolished.

Pictured is an endwall of a warehouse structure. While the wall was very well reinforced, there was no tie in between the vertical wall reinforcement and the bond beam (sound familiar?)
